Gunderboom Fouling Studies in Bowl ine Pond
July 2001

P.A. Henderson, R. M. Seaby, C. Cail es and J.R. Some

July 2001

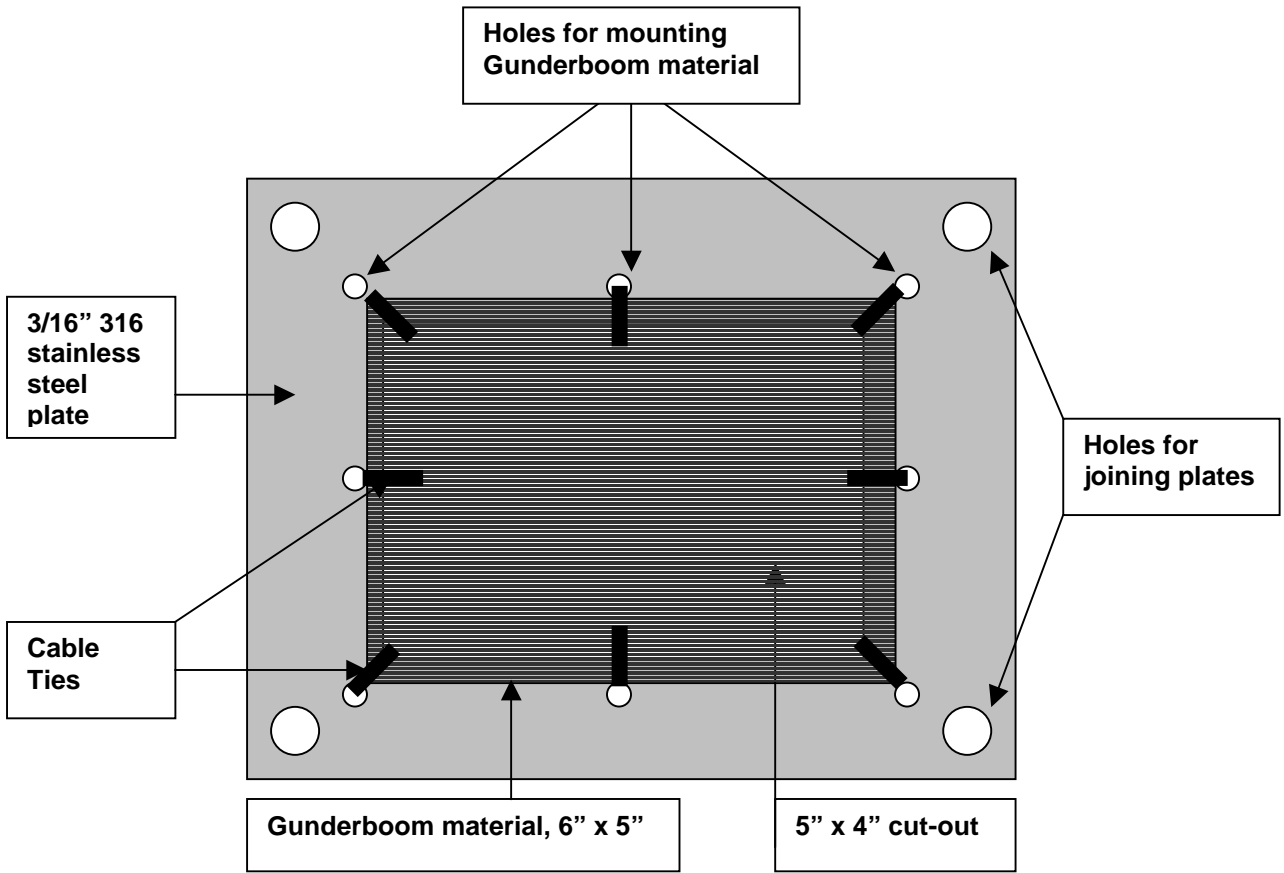
Figure 1 – The metal plates used for mounting the Gunderboom material.

The pieces of Gunderboom fabric, 5 inches by 4 inches, were fixed to stainless steel plates with a hole cut in the centre (Fig 1). Spacers and bolts were used to attach the plates together in pairs to mimic the two layer structure of a working Gunderboom (Fig 2). A neoprene sleeve was attached to stop light penetration between the plates. Six ropes were hung from the oil boom in front of the power station intakes in Bowline Pond. Three plates were positioned, vertically, on each rope at 3, 9 and 15 feet from the surface. Three of the six ropes had single control plates attached at each depth. The control panels were a coarse nylon mat commonly used for fouling studies and known to readily foul

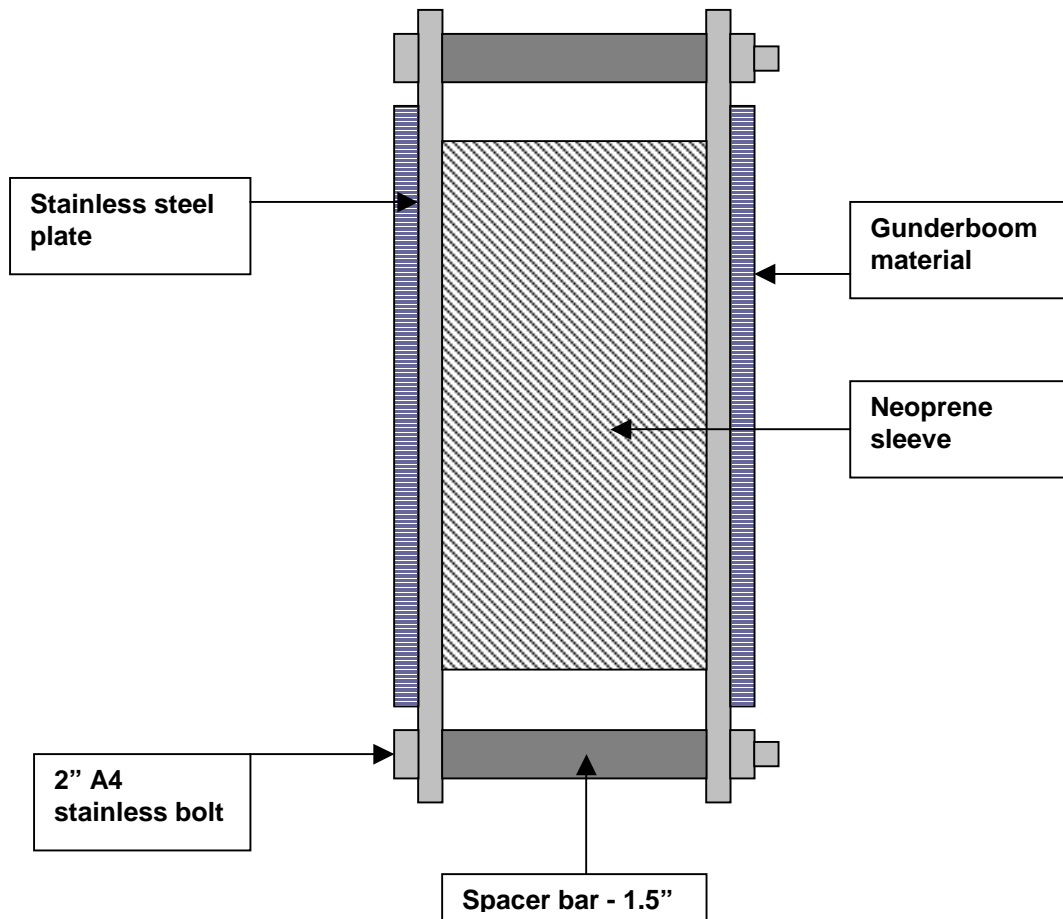
Figure 2 - Side view of a pair of plates.

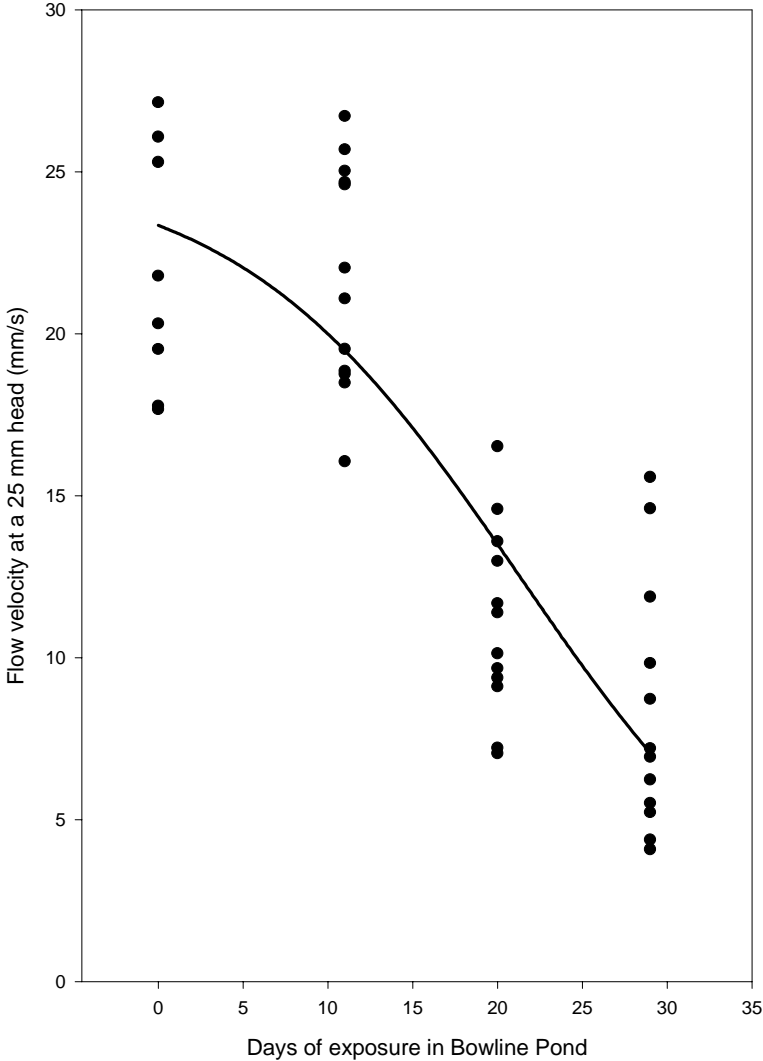
Static fouling tests: the change in flow rate with time in the water for Gunderboom material.

Statistical analysis using an ANOVA showed that there was no significant difference in the flow across panels submerged at different depths. It was therefore possible to combine observations from all the individual test panels when analysing the change in permeability through time. Table 1 gives the flow rate in millimetres per second across all the tested panels. As can be seen there is a large, statistically significant, decline in mean permeability through time. The rate of change of permeability is not constant and almost no change was observed after the initial 11 days exposure. Between 11 and 20 days exposure an almost 50% reduction in flow was observed. Subsequently, the rate of decline was reduced. This general pattern of change could be described by a sigmoid curve as shown in Fig 3. After 11 days of exposure the average flow was 21.8 mm/s, which is effectively identical to that of the clean material. After 20 days exposure, average flow was reduced to 11.1 mm/s, which is 50.7% of the flow of clean fabric. After 29 days exposure, the average flow was reduced to 8.35 mm/s which is 38% of the flow through clean material.

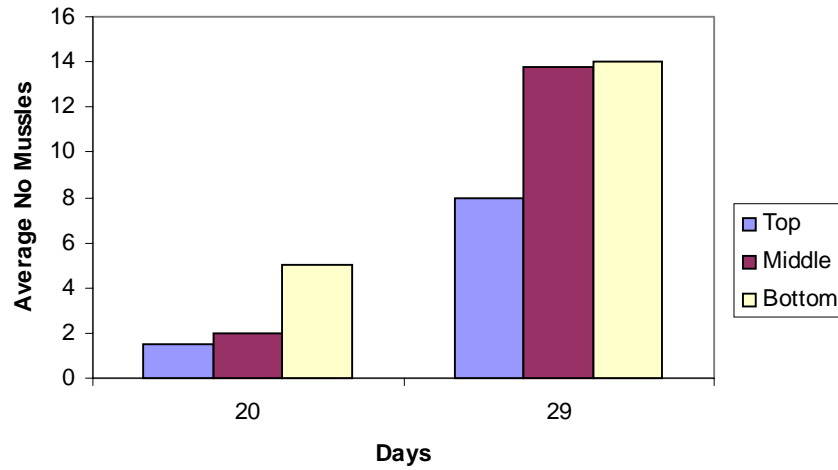
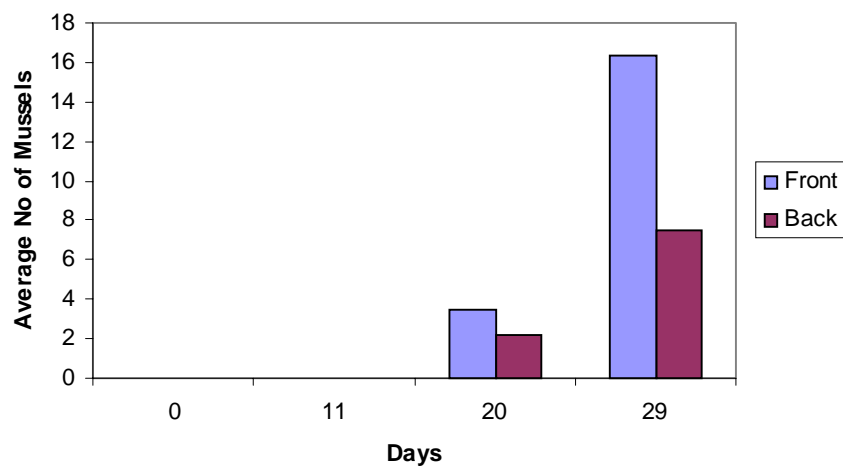
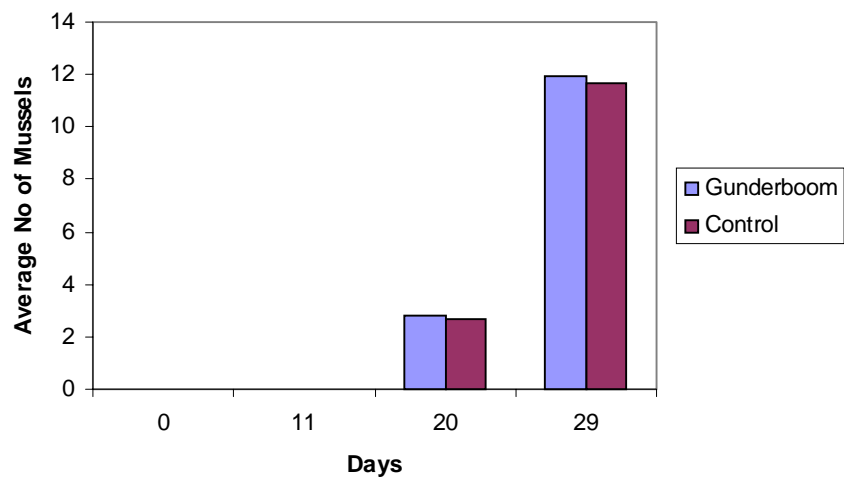
Figure 5

a) Average number of mussels found on the Gunderboom panels at different depths over time.

b) Average number of mussels on the front and back of a Gunderboom panel over time.

c) Average number of mussels found on the Gunderboom and control panels over time

From day 20 onwards, young mussels were found attached to the fabric (Plate 8). All mussels found on either side of the fabric were noted (appendix 3). Table 6 shows the number of mussels found at each depth. The number of mussels was lowest near the surface (Fig 5a).

As shown in Table 7, there were more mussels attached to the front of the fabric (Fig 5b).

Table 8 shows the general increase in the number of attached mussels through time. The number increased rapidly between days 20 and 29 (Fig 5c). No significant difference in the number of mussels attaching to the Gunderboom and control fabrics was found.

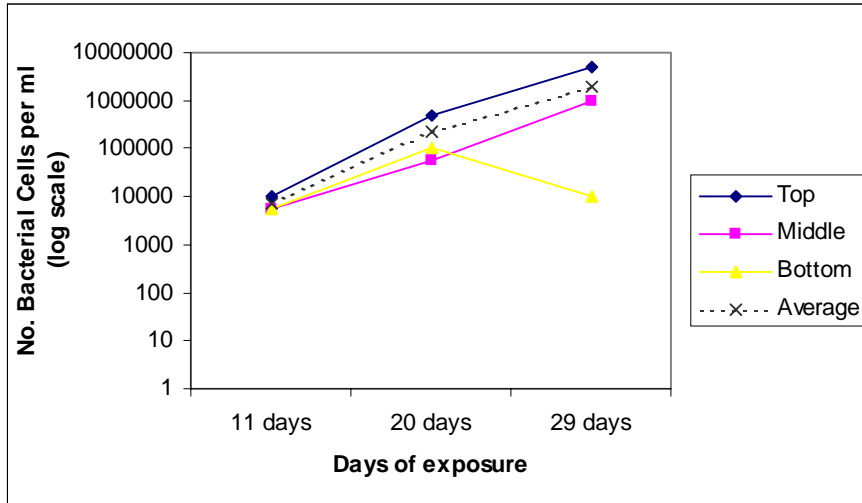
Figure 6 - Bacterial Dip-slide Results for Gunderboom Panels

After 11 days exposure, the average abundance of bacteria extracted from the Gunderboom panels was 7×10^3 bacterial cells per ml. This increased to 2.2×10^5 cells per ml after 20 days and to 2.02×10^6 cells after 29 days. While the bacterial dip-slide analysis showed an overall increase in bacterial numbers over the 29 day period, the bottom panels showed a decrease from day 20 to day 29. Figure 6 plots the trends observed, the data are shown in Table 9.

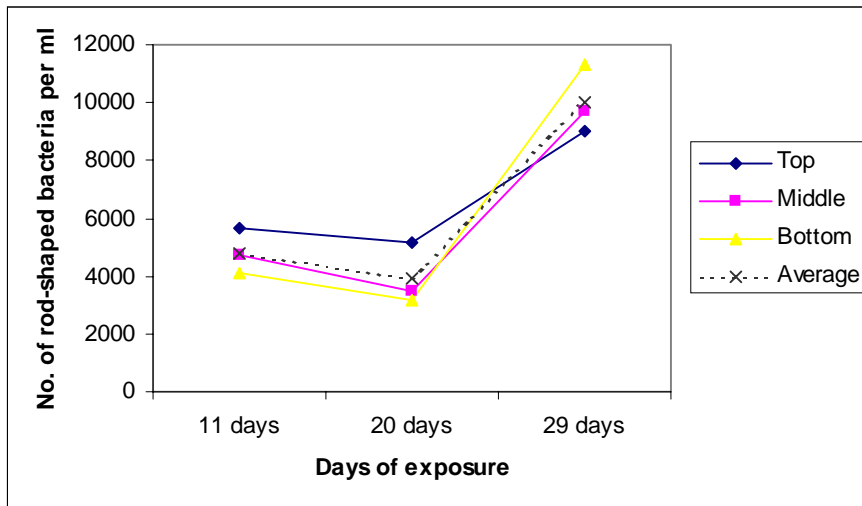
Figure 7 - Live Count Results for the Gunderboom Panels

Figure 7 shows the results of the live counts of rod-shaped bacteria extracted from the Gunderboom panels. After 11 days the average number of bacteria per ml was 4806. By 20 days this had dropped slightly to 3922 bacteria per ml, followed by an increase to 10006 bacteria per ml by day 29 (Table 10).

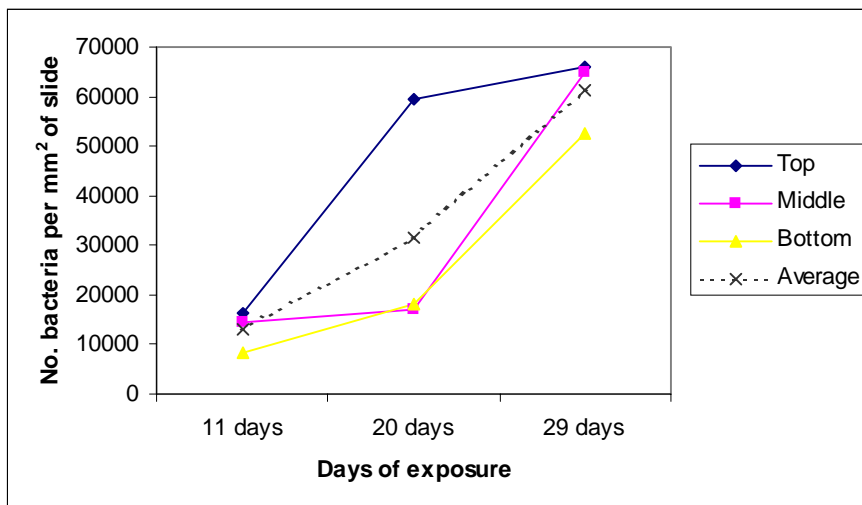
Figure 8 - Stained Slide Count for the Gunderboom Panels

The stained slide method showed an overall increase in bacterial numbers through time on the Gunderboom material, at all depths. The average trend is plotted in Fig. 8. No relationship between panel depth and bacterial number was detected.

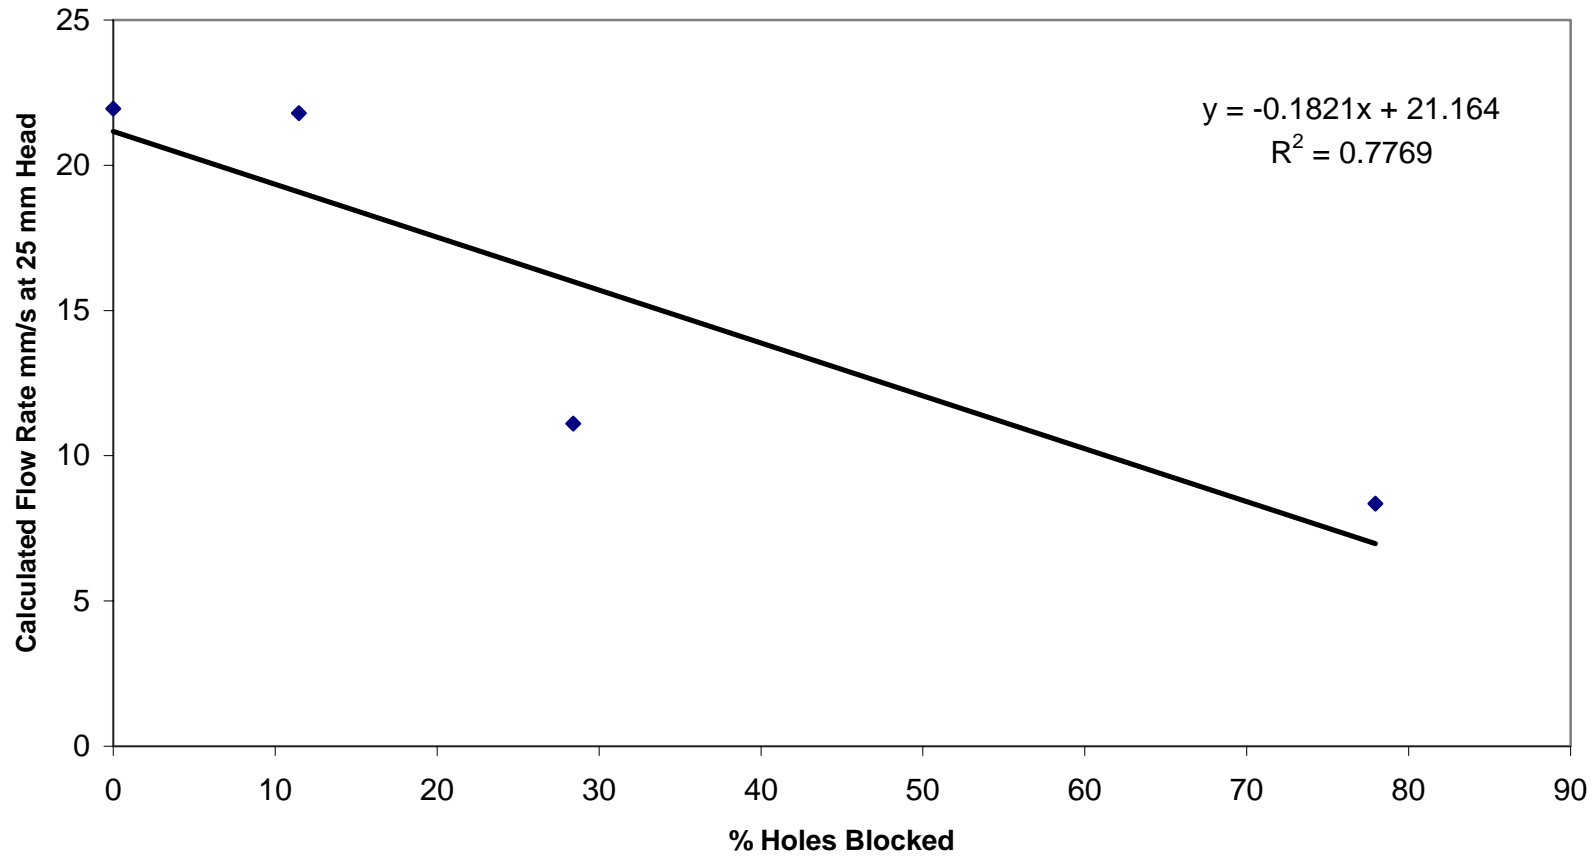
Figure 9 - Calculated flow through the Gunderboom fabric (mm/s) and the percentage of holes blocked

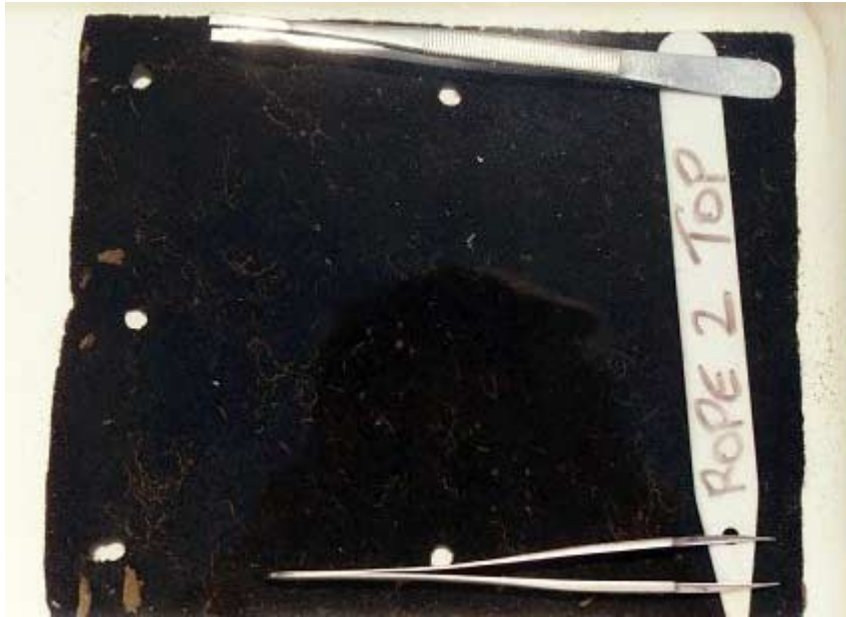
Plate 1

Gunderboom that has been in Bowline pond for 11 days at a depth of 3 feet

The fouling community gradually developed over the 30 days of the study and there was a steady increase in fouling on the surface (Plates 1, 2 & 3) and at a smaller scale

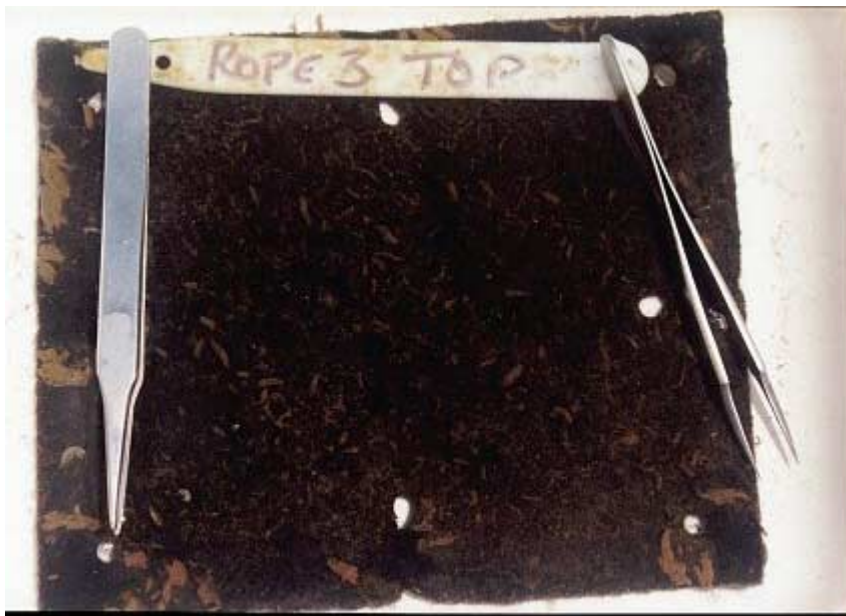
Plate 2

Gunderboom that has been in Bowline pond for 20 days at a depth of 3 feet

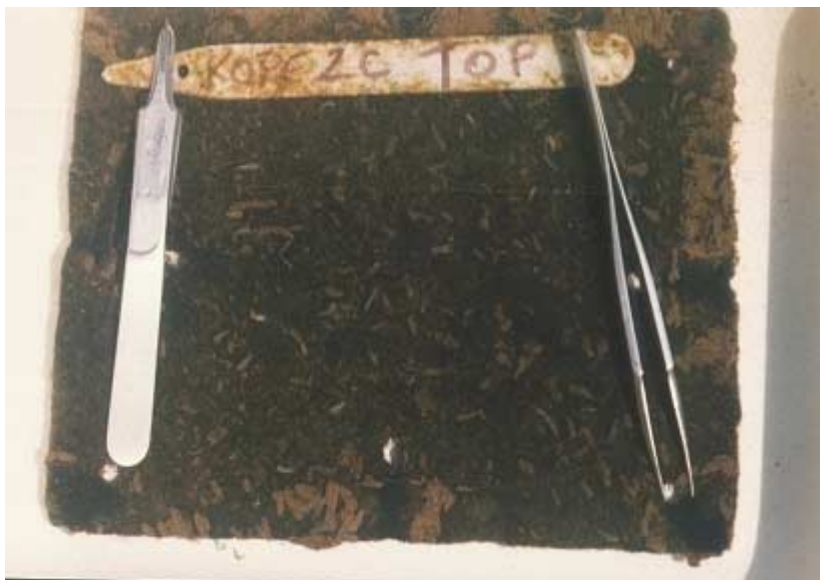
Plate 3

Gunderboom that has been in Bowline pond for 29 days at a depth of 3 feet

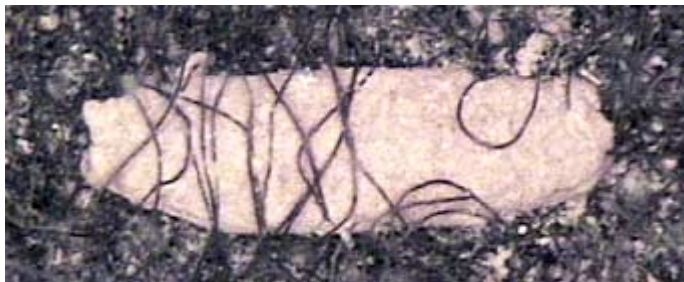
Plate 5
Corophium tube (x6)
A surface tube
showing the use of
fibres to bind the
Corophium to the
fabric.

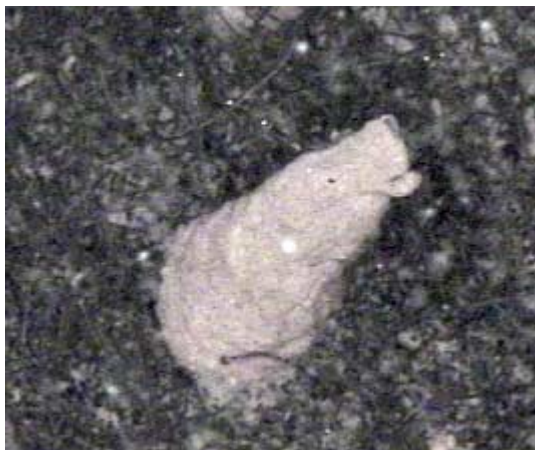
Plate 6
Corophium tube (x6)
A tube passing
through one of the
pre-made hole in the
fabric.

The 1 mm holes through the fabric were found to be used by the tube building amphipod, *Corophium* sp (see Plates 6 & 17). The percentage of holes on each piece of fabric that were blocked are given in appendix 2. Table 4 gives a summary of the data and demonstrates that there was little difference in the percentage of blocked holes from panels exposed at 3, 9 and 15 feet. In the first sample, after 11 days, there were more tubes blocking holes in the lower panels than the top or middle panels. This difference had disappeared by the second and third samples.

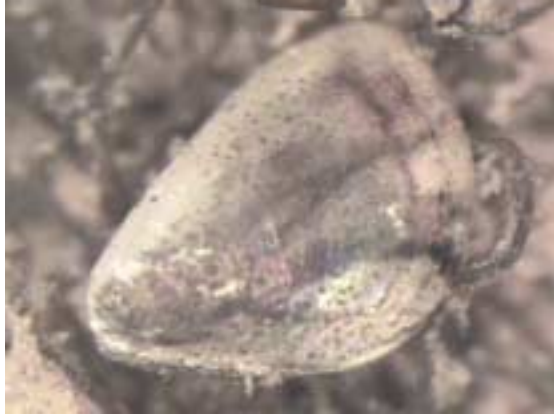
Plate 8
Mussel (x25)
A bivalve mollusc
that attaches itself to
substrates using
threads.

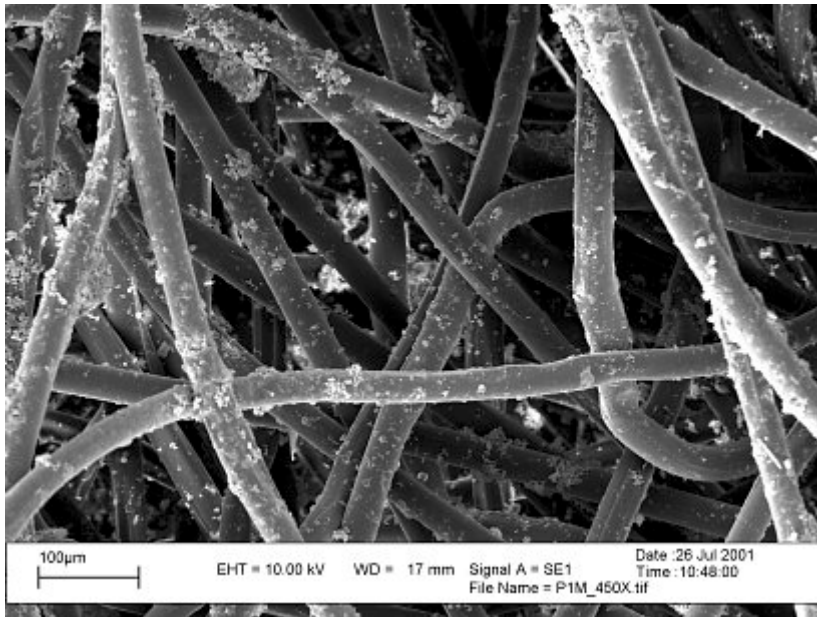
Plate 13
450X magnification
An electron
micrograph of the
fibres of the
Gunderboom after
11 days of exposure
at 9 feet.

in encrusted material on the fabric fibres (Plates 13,14 & 15). Plants were mostly filamentous algae (Plate 11) and diatoms. Typical examples of surface living diatoms observed on the surface after 29 days of exposure are shown in Plates 20 & 21. Single celled animals observed on the surface included both mobile ciliates and attached forms such as *Vorticella* (Plate 10). Dominant multicellular animals within the community included bryozoans, hydroids (Plate 12), copepods, ostracods (Plate 9), *Corophium* species (Plate 4), *Gammarus* species, mussels (Plate 8) and chironomids (Plate 7). A brief description of each type of organism is given in Table 3.

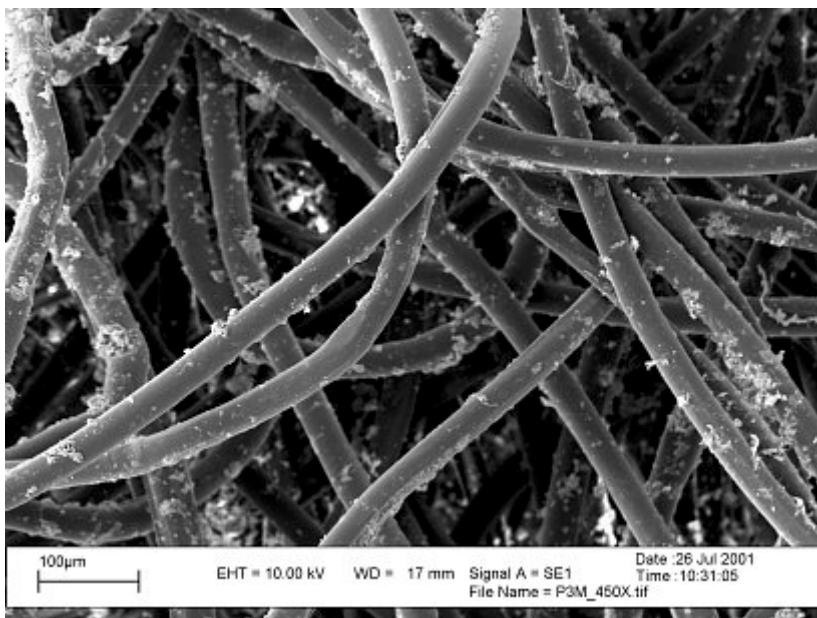
Plate 14
450X magnification
An electron
micrograph of the
fibres of the
Gunderboom after
20 days of exposure
at 9 feet.

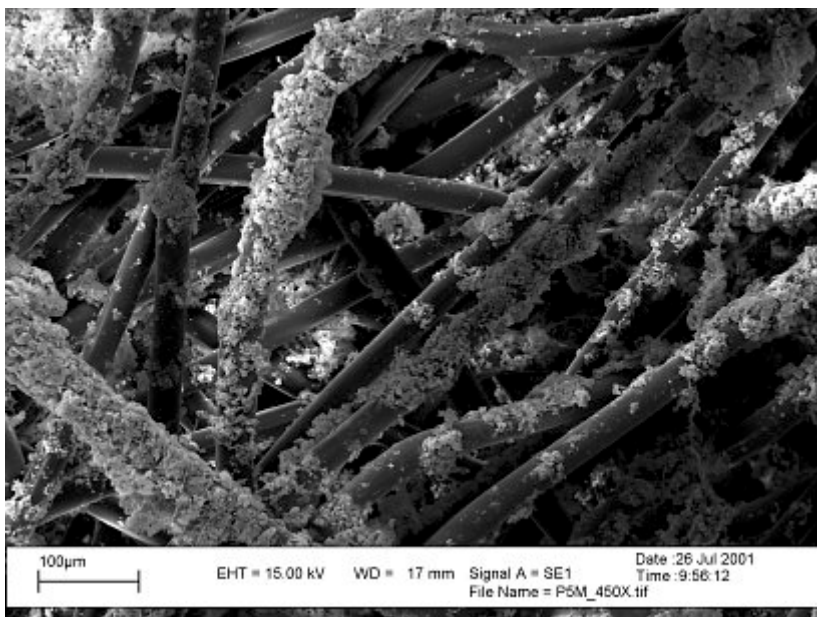
Plate 15
450X magnification
An electron
micrograph of the
fibres of the
Gunderboom after
29 days of exposure
at 9 feet.

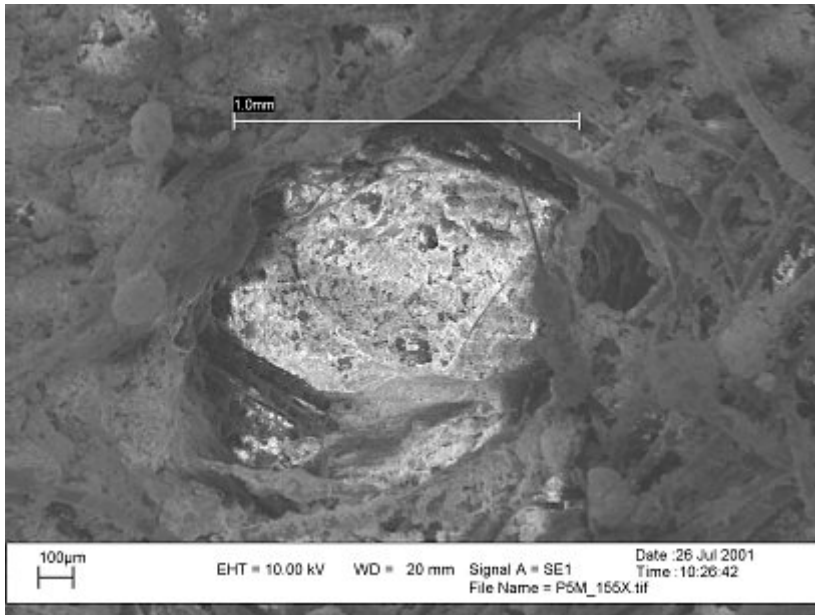
Plate 16
155X magnification
View down a
blocked pre-made
hole of the
Gunderboom after
29 days of exposure
at 9 feet

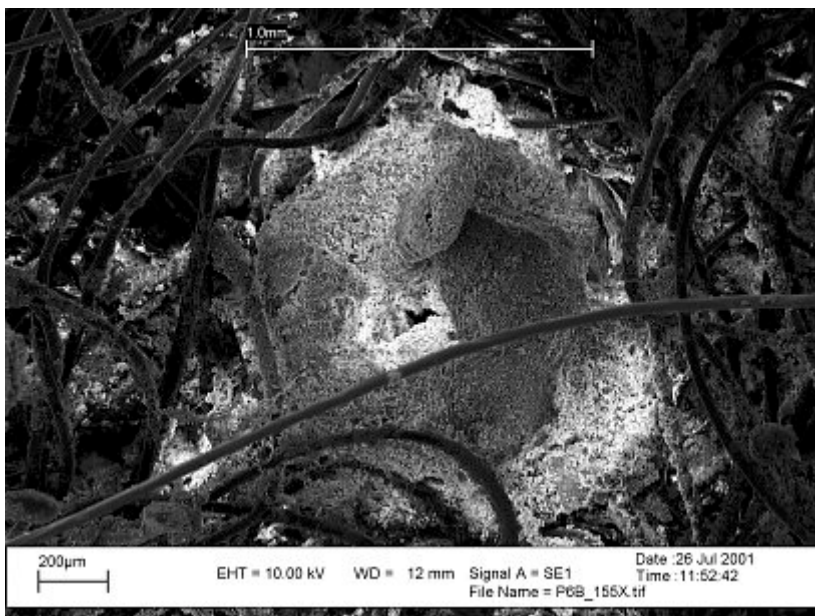
Plate 17
155X magnification
View down a
blocked pre-made
hole in the
Gunderboom caused
by a *Corophium*
tube. 29 days
exposure at 9 feet

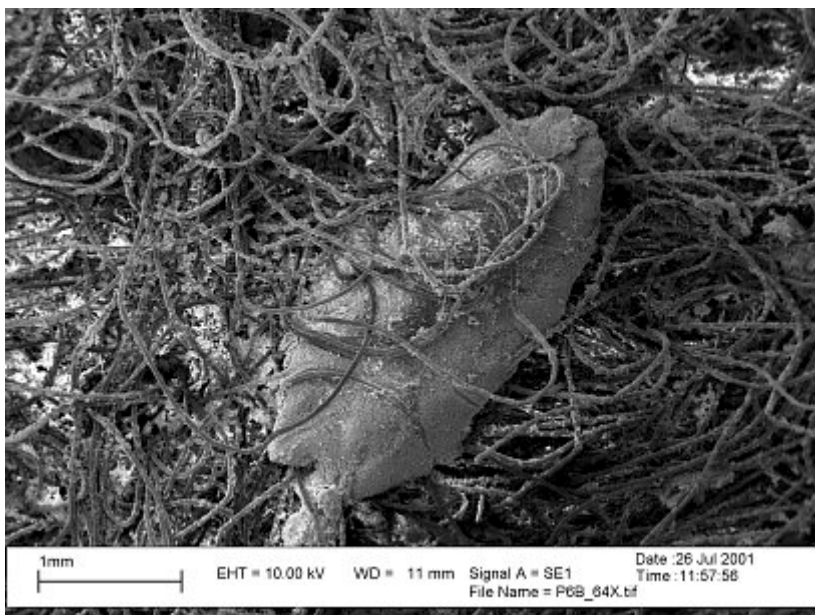
Plate 18
64X magnification
A large *Corophium*
tube across the
surface of the fabric.
29 days exposure at
9 feet

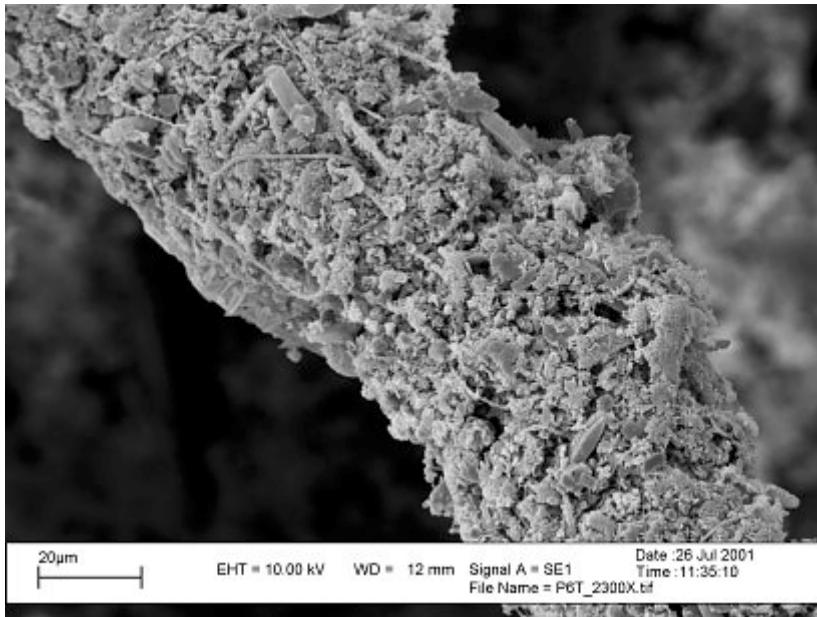
Plate 19
2300X magnification
High magnification of
a fouled fibre showing
encrusting organisms.
After 29 days
exposure at 3 feet

This method was used purely to observe the presence of bacteria growing on the Gunderboom filaments and was not used as a quantitative method. Filaments that were removed, rinsed and placed on agar plates showed clear bacterial growth along the length of the filaments at all depths throughout the duration of the experiment. Bacterial colonies were clearly visible surrounding Gunderboom filaments as shown in plates 24 and 25. These results suggest that bacterial colonisation may be linked to the development of encrusting material on the individual fibres (See Plate 19).

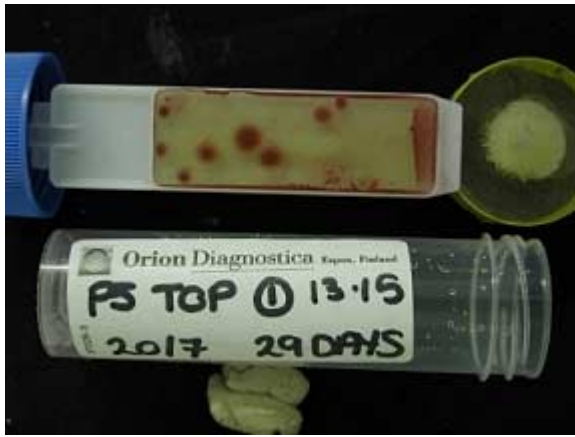
Plate 22

3 feet deep
29 days exposure
A typical dip-slide
showing bacterial
colonies

A typical dip-slide showing bacterial colonies is shown in plate 22.

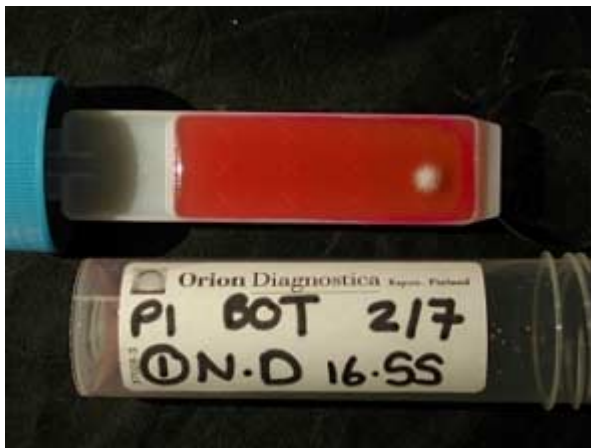
Plate 23

5 feet deep
11 days exposure
A typical dip-slide
showing a fungal colony

A typical dip-slide showing fungal growth on the rose bengal agar is shown in Plate 23.

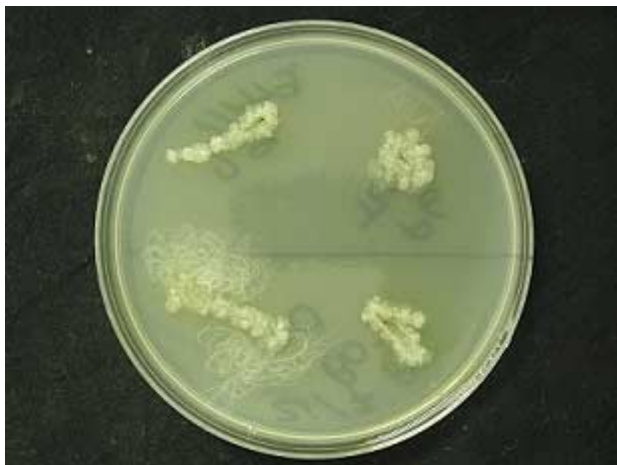
Plate 24

29 days exposure
The top half of the agar
plate shows bacterial
colonies surrounding
fibres from Gunderboom
at 3 feet deep, the bottom
half from 15 feet deep

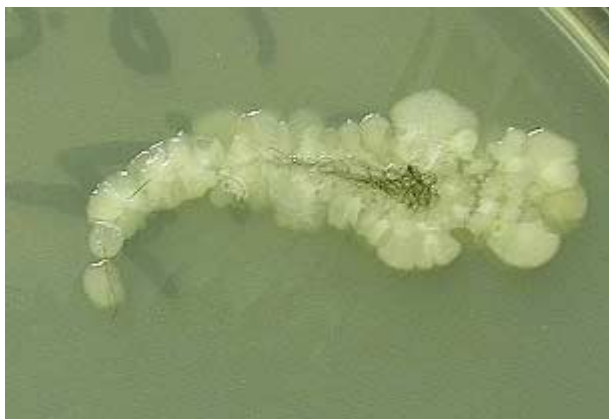
Plate 25

9 feet deep
29 days exposure
Gunderboom fibres
removed and placed on
an agar plate; bacterial
colonies can clearly be
seen following the
fibres.
